MaxLite cites inaccuracies in James Industry response to UL public notice

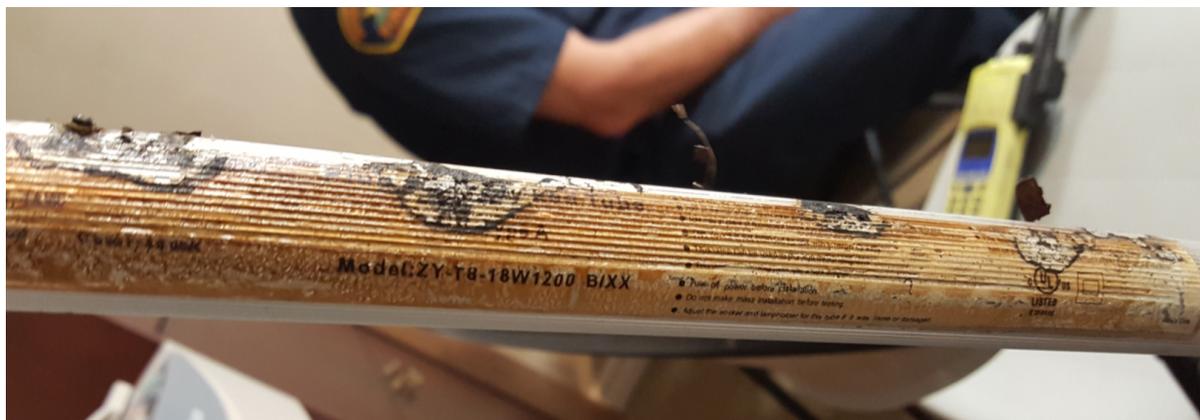
On October 8, 2016, a fire erupted at the four-story Four Seasons Homeowners Association building, located in Beverly Hills, California. The fire and resulting smoke condition caused damage throughout the building and its cause is currently under investigation. The fire began in a James Industries' Direct Replacement Dual-Mode LED Tube (Model Number ZY-T8-18W1200 BIXX).

James Industry Dual-Mode T-8 Replacement Tube Model No. ZY-T8-18W1200 BIXX in which the HOA fire began (cause under investigation).

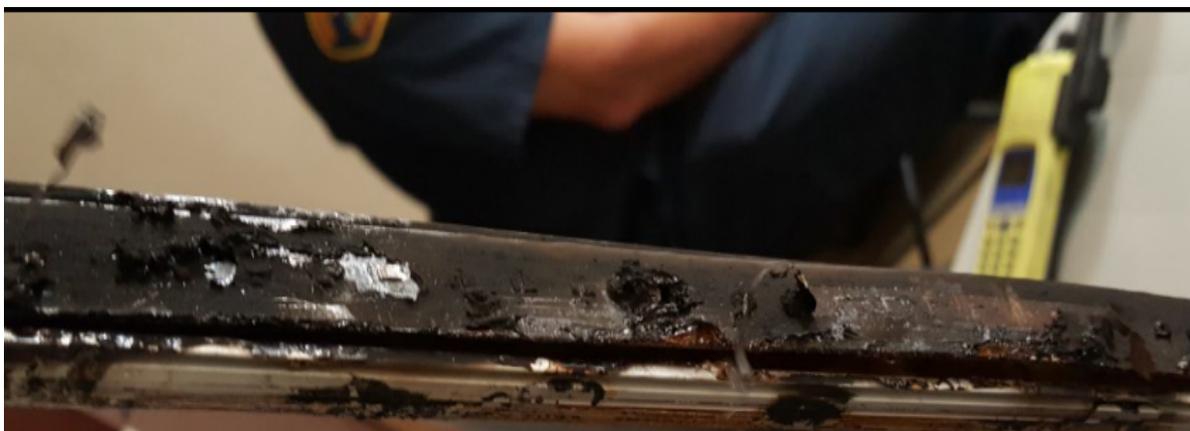
Another view of the James Industry Tube Model NO. ZY-T8-18W1200 BIXX.
